## **Asbestos Management Survey**

**Allison Court**

**Common Areas Only**

**Date: 9<sup>TH</sup> April 2024   Expiry Date: 9<sup>th</sup> April 2025   Prepared by K Howell   Reviewed by C Jelfs**

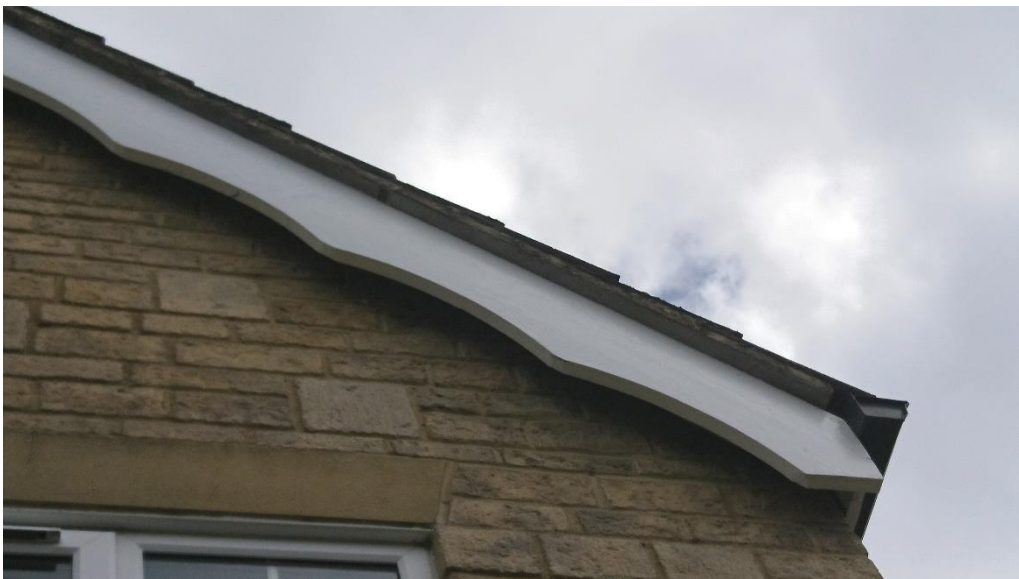
| <b>Reference Number</b> | 1 | | |

| <b>Location/Item</b> | E01 Externals cement undercloak | | |
| <b>Material Risk</b> | 4 | <b>Action</b> | Mark and Manage |
| <b>Amount/Extent</b> | 25LM | | |
| <b>Surveyors Notes</b> | To roof gables at front and side of property | | |
