# Health & Safety Risk Assessment – Amenities Only.

| Address of premises: | 1-8 Allison Court<br>Cheney Manor Road<br>Swindon<br>SN2 2PF |
| Date of fire risk assessment: | 23 <sup>rd</sup> September 2024/ Reviewed September 2025 |

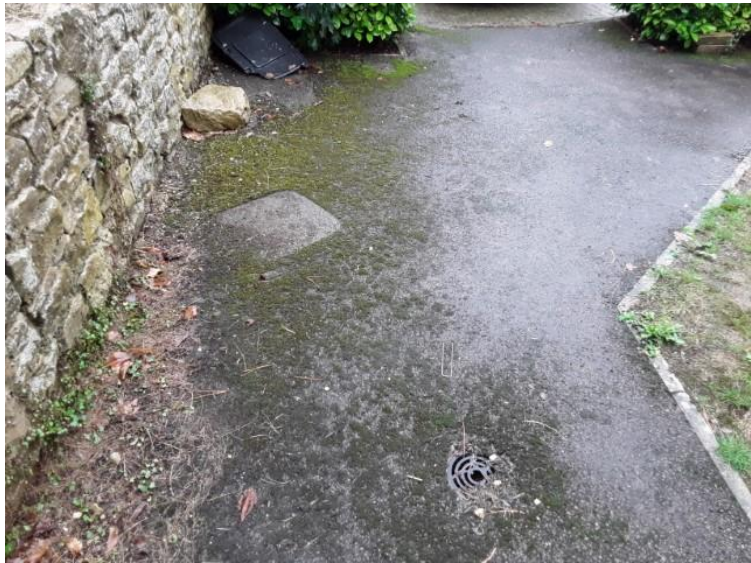
| ACTION PLAN | | | | |
|---|---|---|---|---|
| 01 | <p>It was noted during this assessment that there is a buildup of moss on the path outside unit 8. It is recommended that all moss be removed in order to reduce the risk of a slip occurring. These areas should be monitored at all times.</p> | MED | Client | <p>Ongoing action required</p> <p>Gardening contractor to remove moss as appropriate.</p> <p>Area to continue to be monitored.</p> |

| <b>8.0</b> | <b>SLIP, TRIP AND FALL HAZARDS.</b> | |
|---|---|---|
| | <p>It was noted during this assessment that there is a buildup of moss on the path outside unit 8. It is recommended that all moss be removed in order to reduce the risk of a slip occurring. These areas should be monitored at all times.</p> <p>It was noted during this assessment that from a consultation with the tenant of unit 3 the rear gate was secured with a combination lock on the outside which would prevent egress from the rear path. It is recommended that this gate be kept unlocked and unobstructed from the outside. If a lock is required then it should be installed on the inside in order to ensure this gate can be operated from the inside at all times.</p> <p>Grit / Rock Salt storage should be subjected to an separate risk assessment to include a COSHH assessment and a material safety data sheet for any hazardous materials should be obtained. Regular checks should be made to ensure the grit is useable and sufficient quantities are stored prior to any anticipated cold weather.</p> <p>Hand shovels should be provided for grit dispersal.</p> | |
